Manhole Inspection Summary

Manhole # S37U1_032MH

Insp Date: **4/12/09 3:14 PM**

Location Address: **3442 S. Hanover St.**

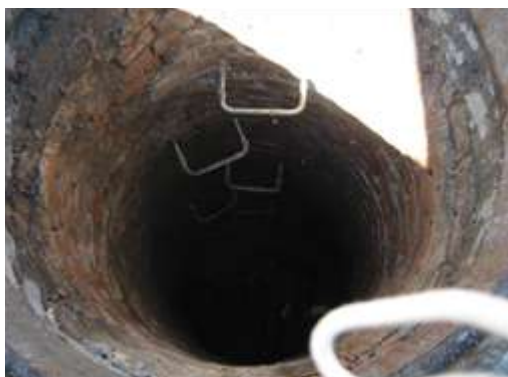
steps

Count: **10** Missing: **0** ☐ Corroded

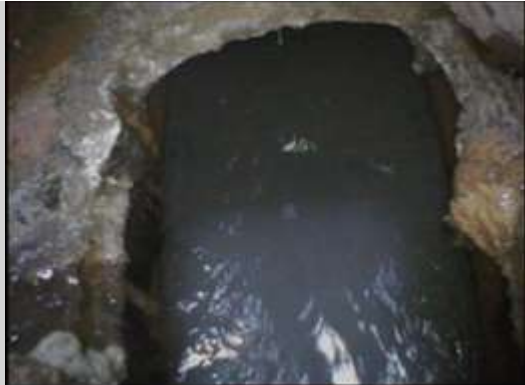
12 O'Clock Outflow

24 in. Circular Gravity Sewer
Pipe Out @ 12 O'Clock

Pipe Height: **22.8** (in.) Rod and Bar (Angled)
Pipe Material: **Clay** ☐ Pipe Lined
Invert Depth: **19.40** (ft.) Flow Characteristics: **Fast**
Deposits: ☒ None ☐ Mud ☐ Sludge ☐ Debris ☐ Grease
Silt Depth: (in.) Deposits Extent:
Infiltration: **None** Pipe Seal Cond: **Sound**

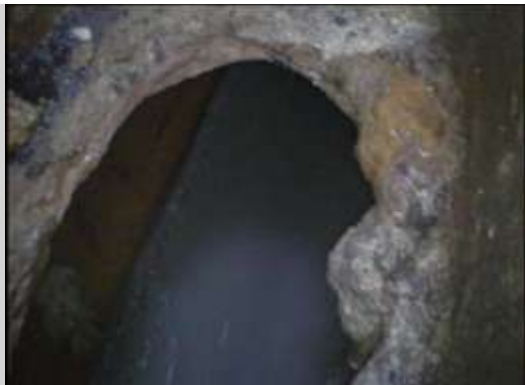
6 O'Clock Inflow

27 in. Circular Gravity Sewer
Pipe In @ 6 O'Clock

Pipe Height: **27.6** (in.) Rod and Bar (Angled)
Pipe Material: **Clay** ☐ Pipe Lined
Invert Depth: **19.60** (ft.) Flow Characteristics: **Fast**
Deposits: ☒ None ☐ Mud ☐ Sludge ☐ Debris ☐ Grease
Silt Depth: (in.) Deposits Extent:
Infiltration: **None** Pipe Seal Cond: **Sound**

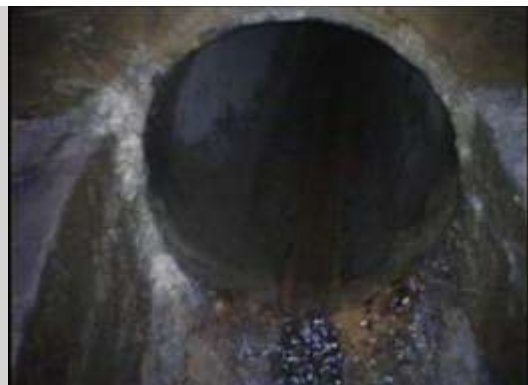
8 O'Clock Inflow

18 in. Circular Gravity Sewer
Pipe In @ 8 O'Clock

Pipe Height: **19.2** (in.) Rod and Bar (Angled)

Invert Depth: **17.30** (ft.) Flow Characteristics: **Slow**

Infiltration: **None** Pipe Seal Cond: **Sound**
